Status of FPIX Production

A.Hahn

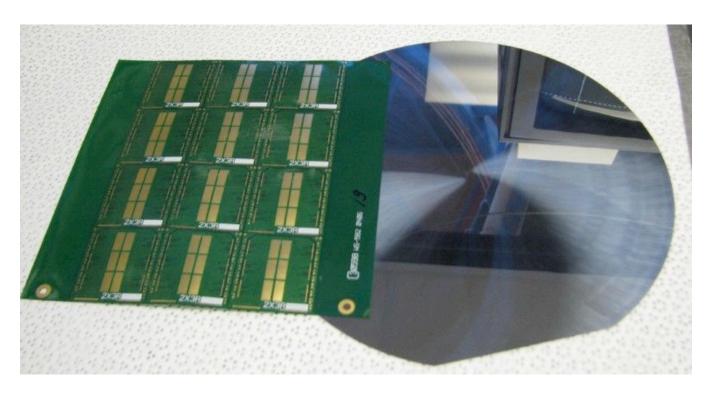
VHDI Production

- •Flex circuit laminated to 300μ Si Wafer with 3M9882 (50 μ thick) Thermally Conductive Adhesive Tape
- Probe Tested at KSU for electrical faults

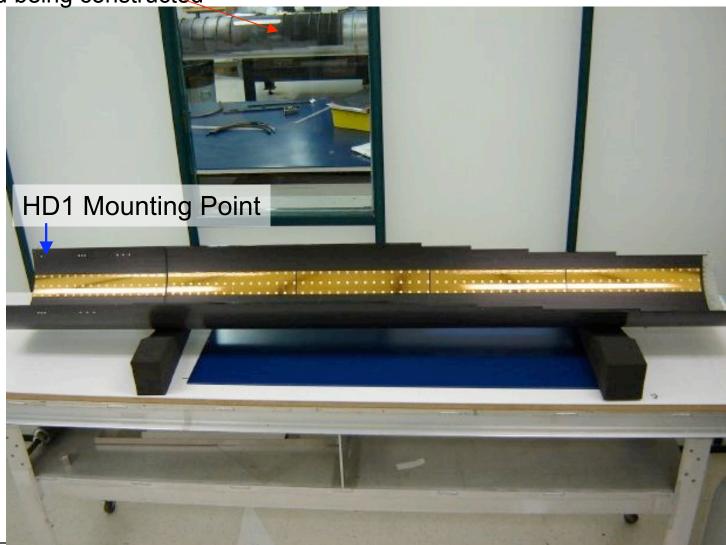
First Production Half Service Cylinder (for 2007 Pilot Run)

2nd being constructed

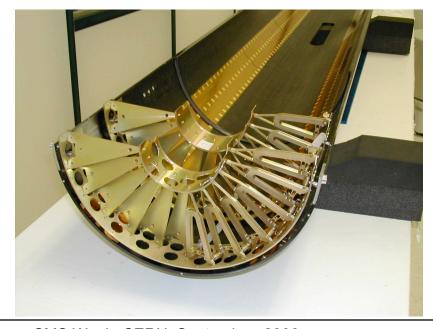
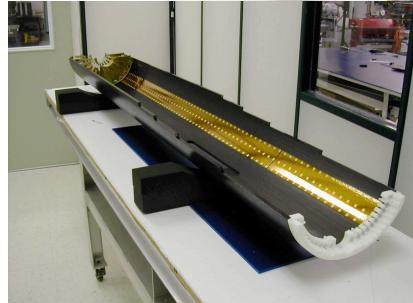
2007 Pilot Run Half Disks in 1/2 Service Cylinder

- Pilot Run Panels are ready
 - •Mounting onto 1/2 disks next week
- •Plan for Pilot run Detector to be completed end of October 06 and shipped to TIF
